Coal Mine Fatal Accident 2004-01

Operator:	Canyon Fuel Company, LLC
Mine:	SUFCO Mine
Accident Date:	January 3, 2004
Classification:	Machinery
Location:	District 9, Salina, UT
Mine Type:	Underground
Employment:	281
Production	28,500 tons/day

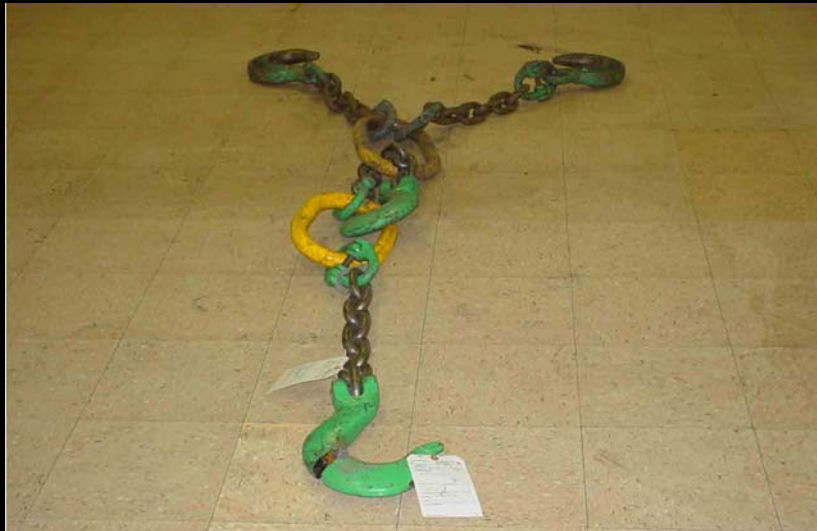
- A longwall shearer operator arrived and offered to assist.
- The shearer operator requested that 2-legged chain slings, customarily used during longwall moves, be brought to the section so that another method of rigging could be attempted.
- The slings were delivered and carried to No. 49 shield.
